# **STABILIZATION OF LAND SLOPES IN SOUTHEASTERN OHIO**

**G. O. SCHWAB**

**OHIO AGRICULTURAL RESEARCH AND DEVELOPMENT CENTER  
WOOSTER, OHIO**

**ON THE COVER:** Terrace failure at the Eastern Ohio Resource Development Center, May 1973.

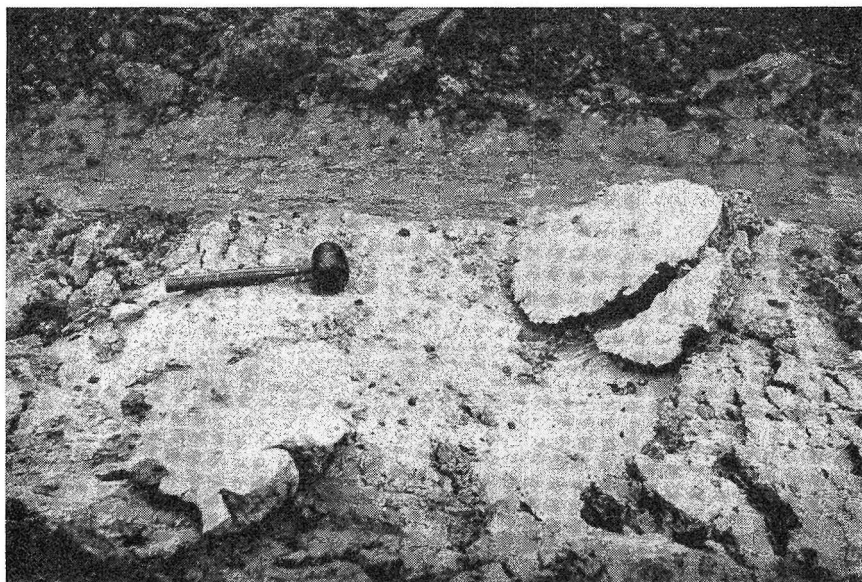
**FIG. 6.—Example of “slickenside” observed during construction of the bench terrace.**

were observed during construction as shown in Fig. 6. The soil slid on these surfaces when the soil was excavated with a scraper. These slip planes were less than one-eighth of an inch in thickness. Hooper (12) also observed these slickenside planes in the trench wall of his excavations. These were more numerous near the lobate terrace landforms (mounds), but were nearly continuous down the slope at depths from 3 to 12 feet extending 30 to 40 feet laterally from the trench. These planes were found at the boundary between two dissimilar clayey soils. The American Geological Institute (1) defines a slickenside as a polished and smoothly striated surface that results from friction along a fault plane

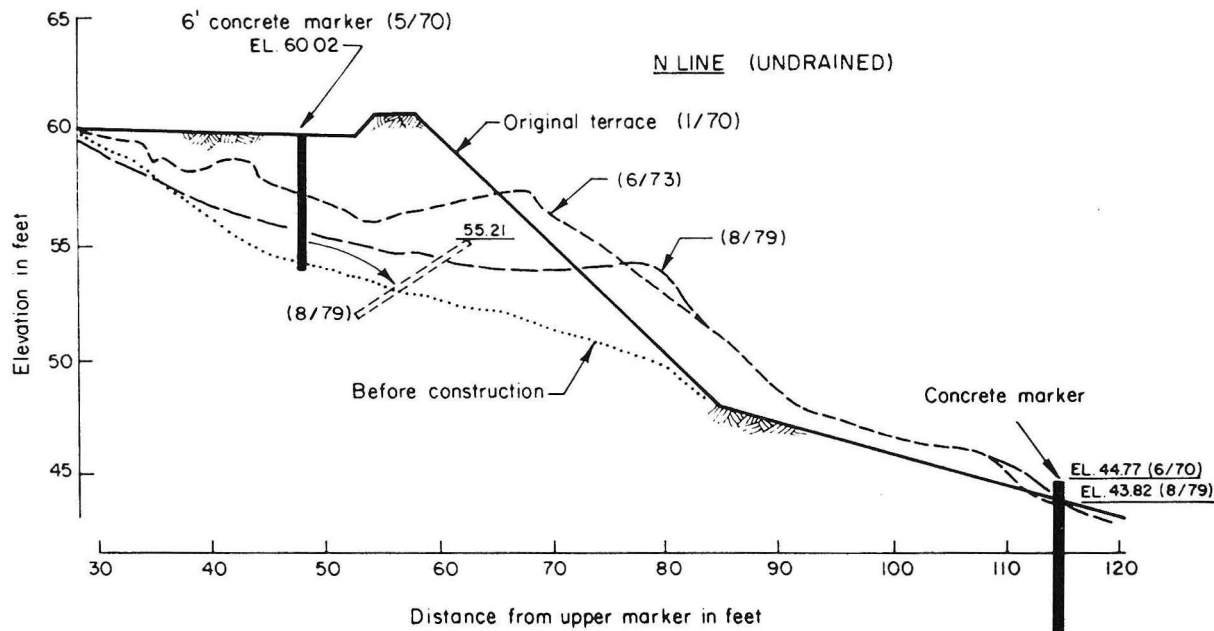
The bench terrace failed about March 20, 1973, 3 years after construction. Small cracks were noted near the outer rim in the Spring of 1972. Failure occurred mostly as a rotational slide with deformed units within the slide as shown in Figs. 7 and 8. Eckel (6) describes such a slide as a Class IIB type. The upper surface of failure typically has a back slope toward the uphill side. The tipping of the upper concrete marker in Fig. 7 showed evidence of slide movement near the surface which is not typical of a rotational slide. The lower section of the slide moved down slope with an increase in elevation of the surface, which is typical of a rotational slide. Cross sections were taken in June 1973, about 3 months after the initial failure, and resurveyed about every 2 years thereafter. The cross sections taken in 1975 and 1977 are not shown in Figs. 7 and 8, but they would plot somewhere between the (6/73) and (8/79) lines. The top of the upper concrete marker in Fig. 7 moved horizontally downhill 13.7 ft. and dropped 4.8 ft. in elevation compared to the markers next to the road, which showed no movement. Figure 9 is a photo of the marker and slide area. The upper marker in Fig. 8 in the drained section moved only 0.3 ft downslope and only 0.18 ft lower in elevation during the 9-year period.

FIG. 7.—Cross section of the bench terrace through undrained end (N) before and after failure.

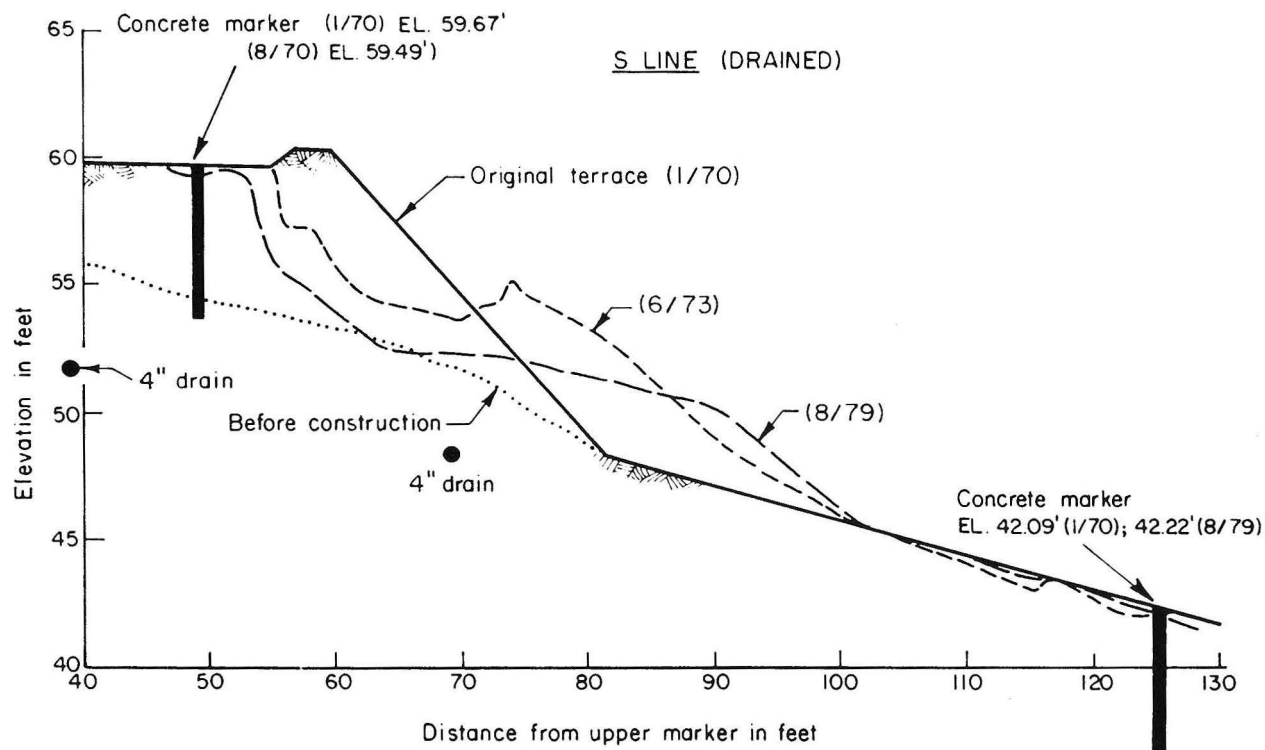
FIG. 8.—Cross section of bench terrace through drained end (S) before and after failure.

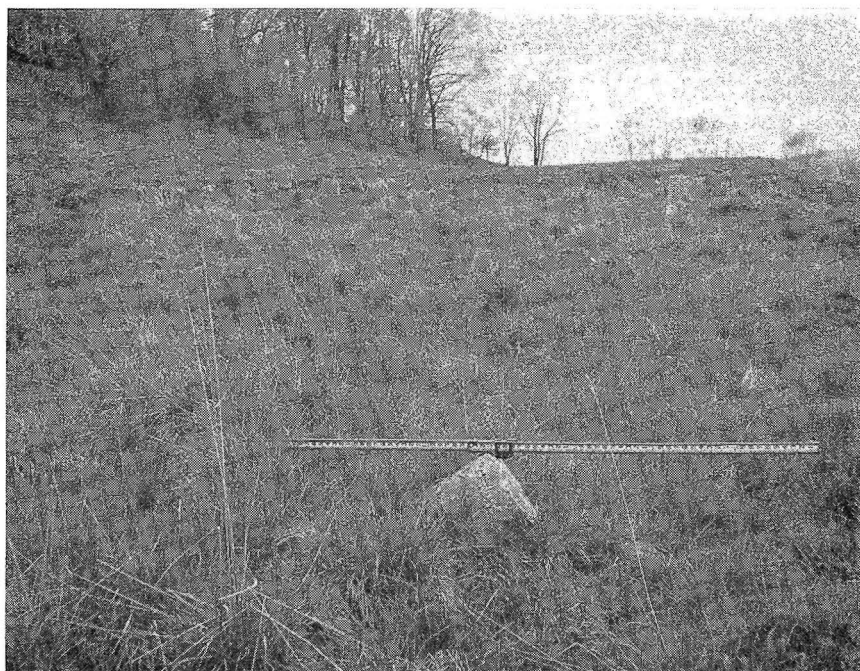
FIG. 9.—Failure section of bench terrace in 1979 showing concrete marker on N line near outer ridge.

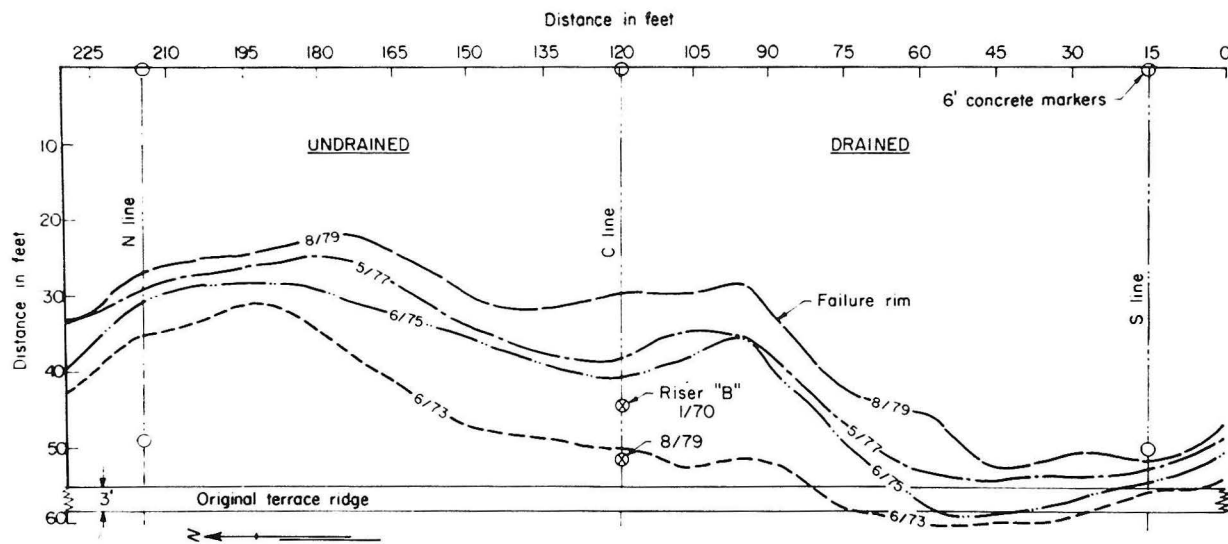
The upper edge of the slide called the failure rim is shown in Fig. 10. Figure 11 shows the failure rim with the drained section in the foreground. The average distance of movement at 2-year intervals is shown in Table 3. This distance was arbitrarily measured from the outer edge of the original terrace ridge. The distances for the undrained section were taken between the N and the C lines, and those for the drained section were taken between the C and the S lines. The drains appeared to reduce the initial slide area (6/73), but movement of the failure rim for the drained and the undrained sections was nearly the same thereafter. The initial failure disrupted the main 8-inch drain line. The lower 50 feet were replaced in September 1973. By about 1977, the outlet pipe was again covered up by the slide and drainage was again impaired.

FIG. 10.—Top view of bench terrace showing edge of failure rim from 1973 to 1979

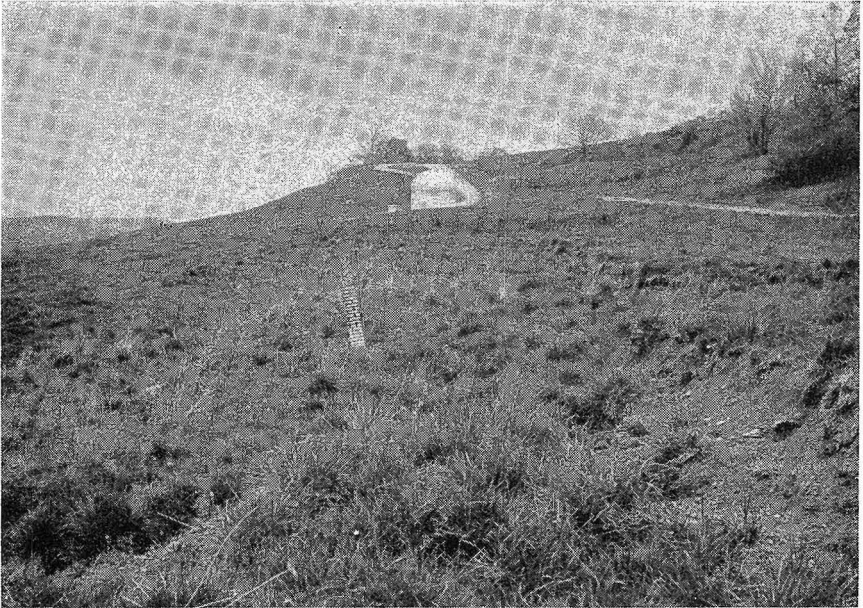
**FIG. 11.—Failure rim of bench terrace in 1979 looking north.**
